# Project Proposal

Locations: Central  
London

ZINGA® TREATMENT FOR REGENT  
STREET DISEASE

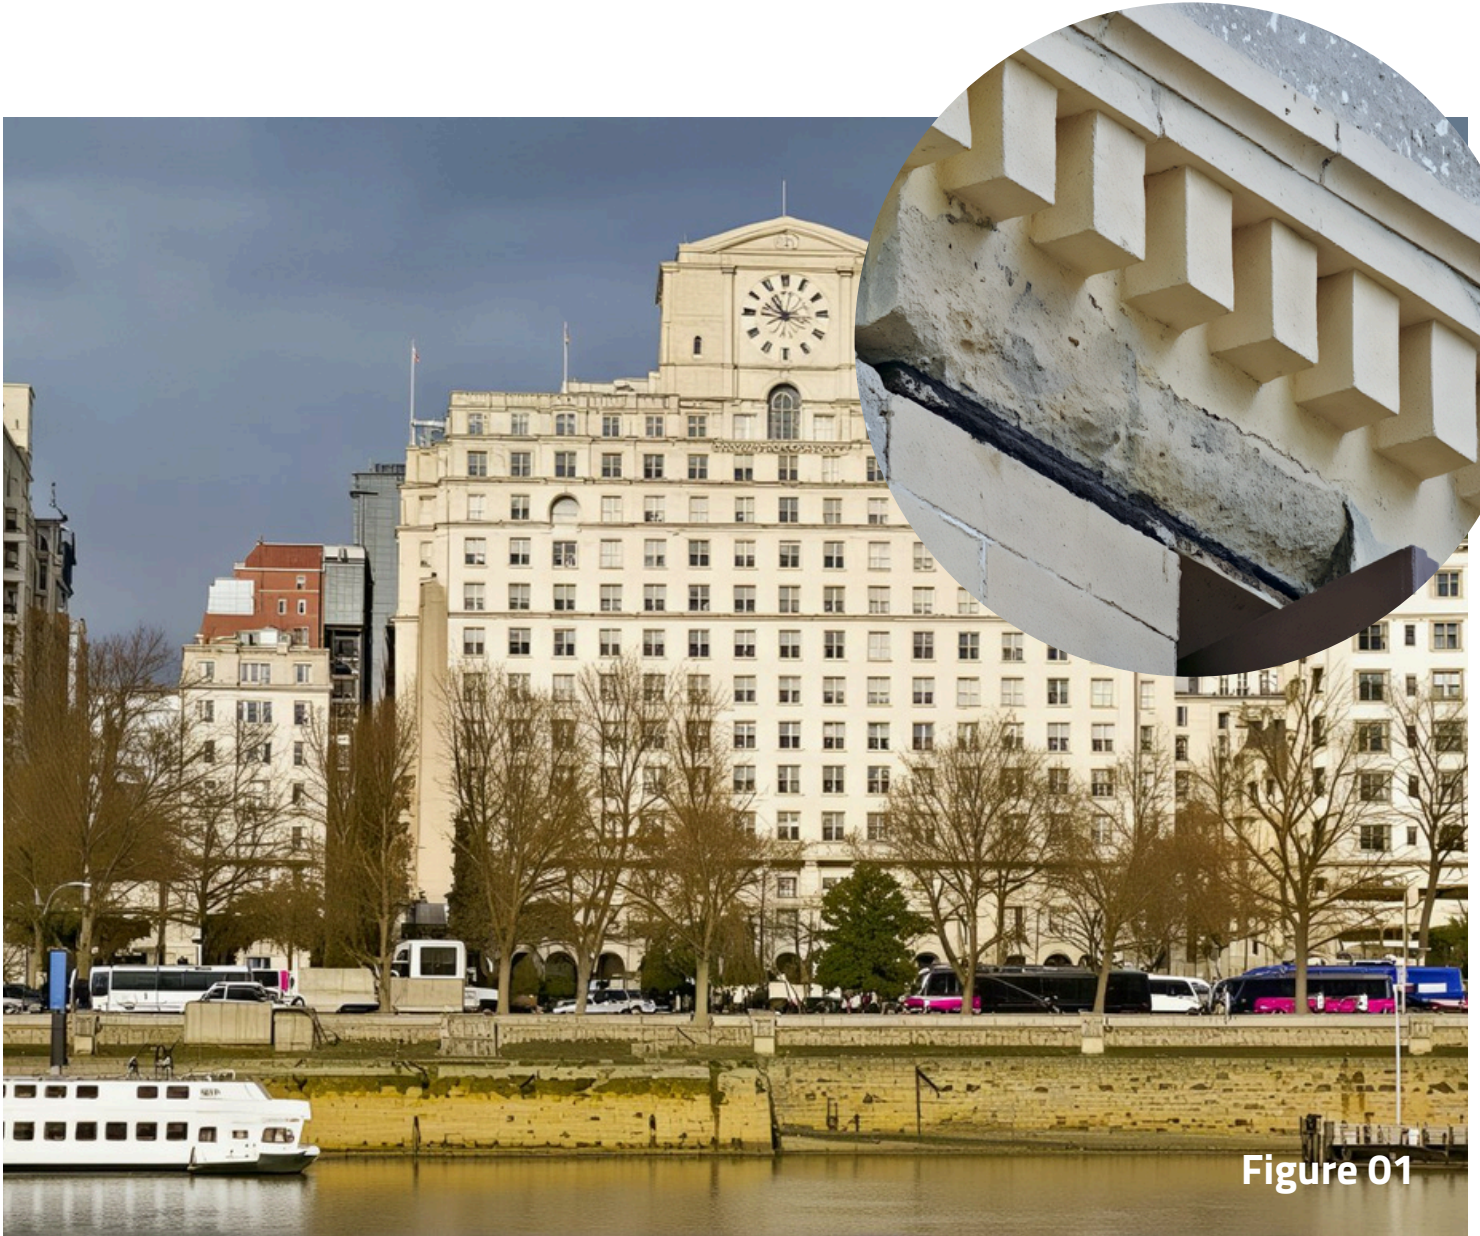
Figure 01

The building shown here on figure 01 has experienced a horizontal form of rust-jacking, which has actually lifted the steel lintel (plus the weight of the stonework above it) off the blockwork below it. This demonstrates the amazing pressures that can be built up over time when steel or iron corrodes

The moisture ingress on the lower front of the stonework shows what can happen when the moisture subsequently freezes in the winter months, with the expansion of the ice exfoliating the surface of the stonework.

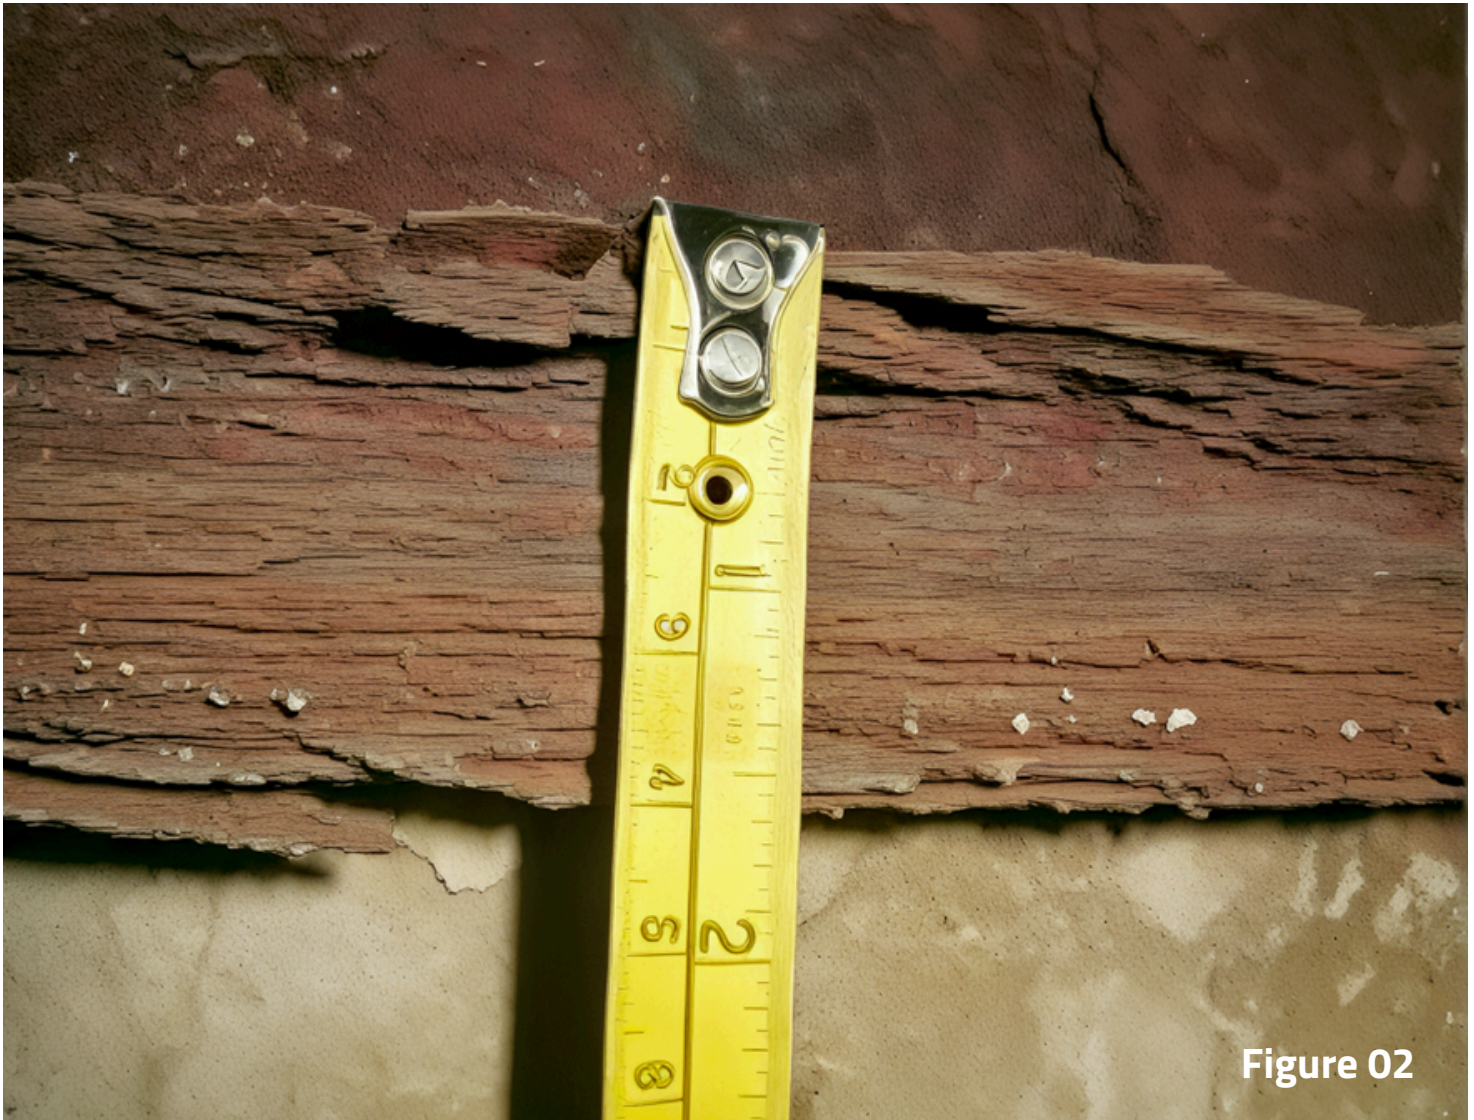
Figure 02

His photograph clearly shows that a 9 mm beam flange (3/8 inch) has corroded very badly over time, with the steel striating into layers and expanding to 41 mm in thickness (1 <sup>5</sup>/<sub>8</sub> inches).

This is further evidence of the incredible pressures and stresses induced by rusting steel or iron.

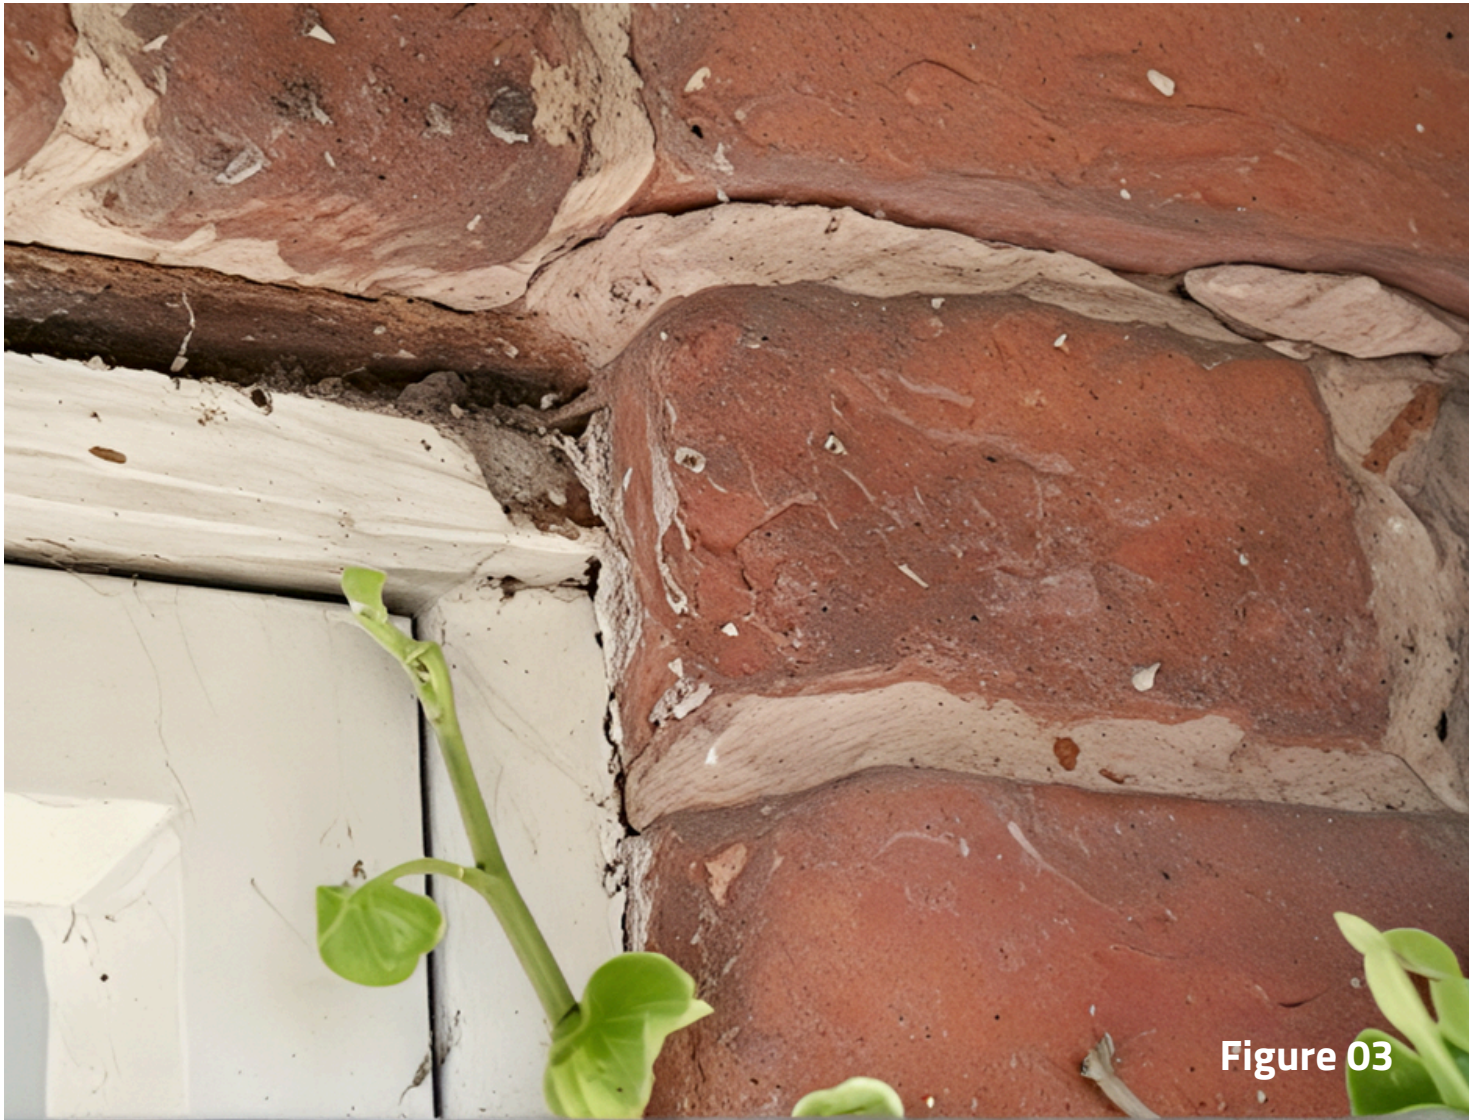
In the photograph on figure 03, it can be seen that the steel lintel has corroded and expanded vertically, lifting the brickwork above the wooden window frame and also lifting the bricks within the supporting wall as well

This separation will weaken the structure quite severely, and it will require urgent remediation to prevent the damage from escalating any further to the point where structural failure will be taking place. There is, unfortunately, no short cuts or 'quick fix' methods to repair such damages.

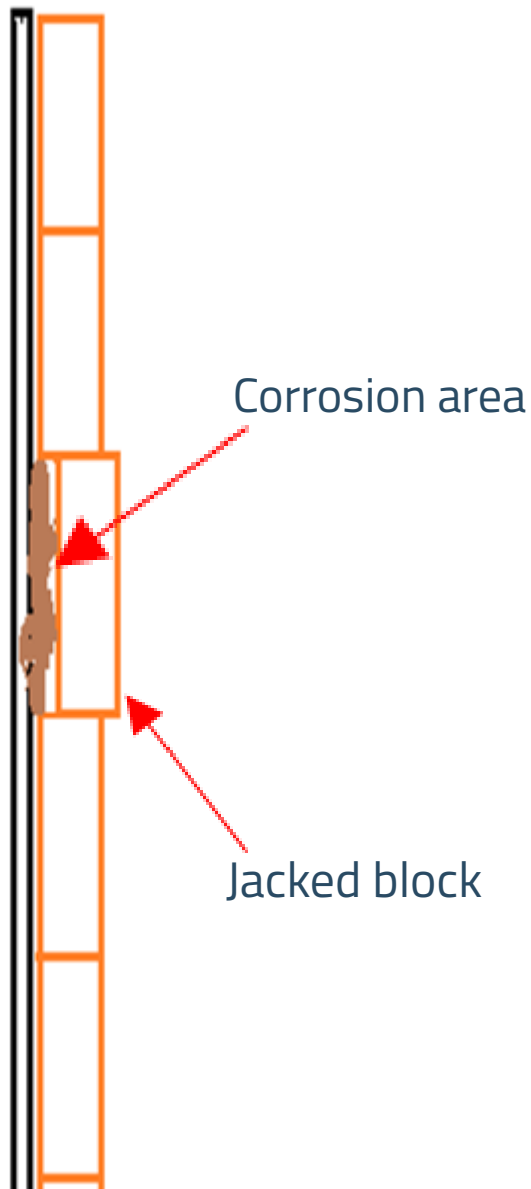
On the left is a rough drawing giving a sectional view of a building façade, with a steel beam behind the stone blocks that has corroded half-way down its height. The corrosion taking place in that area has increased the original steel volume by up to 200% and the increasing rust-volume has 'jacked' the stone block out of place.

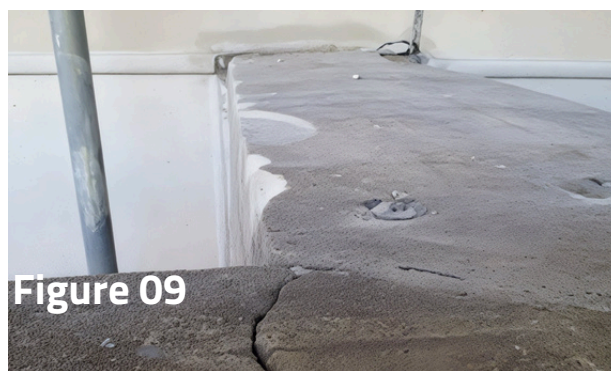
This is a longitudinal crack running parallel to the hidden steel beam inside the concrete, and the damage done can be clearly seen below on figure 10.

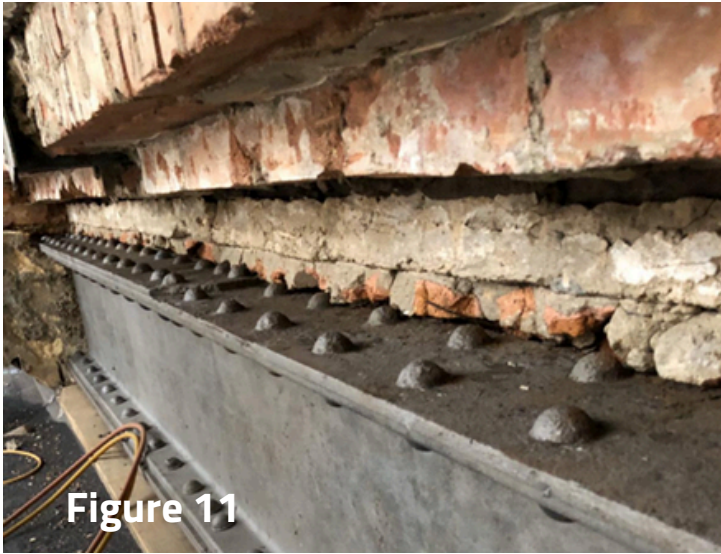
Figure 11

Figure 11: This exposed section of a beam has been blast-cleaned, and the reverse face of the beam still has the original cement and brickwork in place. The beam continues to support all of the brickwork above it, and only the corroded faces of the beam were broken out to be treated,

Where a beam has long lengths of steel surfaces in tight contact with the cement or lime mortar, it is always a better option to use blast-cleaning where possible.

If sharp needle-guns are used, they can vibrate the steel beam and induce small air-gaps between the steel and mortar along the length of the beam. It is always better to maintain the intimate contact between these two surfaces in order to minimize the presence or free movement of moisture and oxygen. This removes two corners of the 'corrosion triangle'.

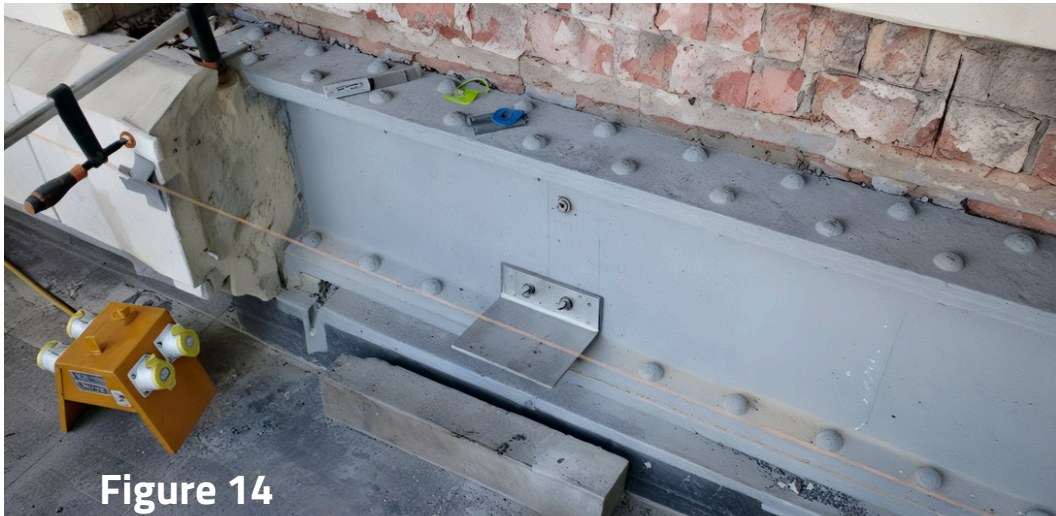
**Figure 14**

The broken-out beam on figure 14 shows a row of smaller stone blocks that have been returned to their original places, with the bedding cement being applied right up to the surface of the ZINGA® coating on the steel.

This type of refurbishment is completely acceptable in this environment, because the zinc coating will only ever expand to a maximum of 10% of its originally installed volume over 100 years.
