# Project Proposal

Locations: Central  
London

ZINGA® TREATMENT FOR REGENT  
STREET DISEASE

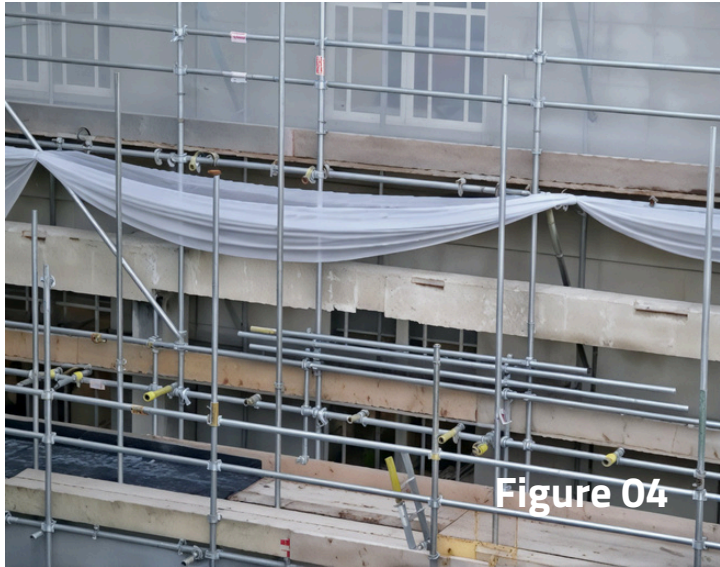
Modern façade inspection techniques play a vital role in the early detection of Regent Street Disease. High-resolution laser scanning is widely used to assess building façades with speed and precision. A full elevation can typically be scanned in under two hours. Surveyors usually position the scanner on the roof to achieve the lowest possible angle of deflection from the façade plane. This allows the 3D scanning system to detect even minute out-of-plane movements or displacements.

In practice, once a stone block has been displaced approximately 50 mm (2 inches) from the façade line, remedial action is generally initiated. This is because a displacement of this magnitude indicates that the steelwork behind the masonry has expanded significantly, most likely due to corrosion. The first operational step in any remediation program involves erecting scaffolding along the affected façade. In some cases, particularly on long street frontages, the scaffolding may extend across an entire city block.

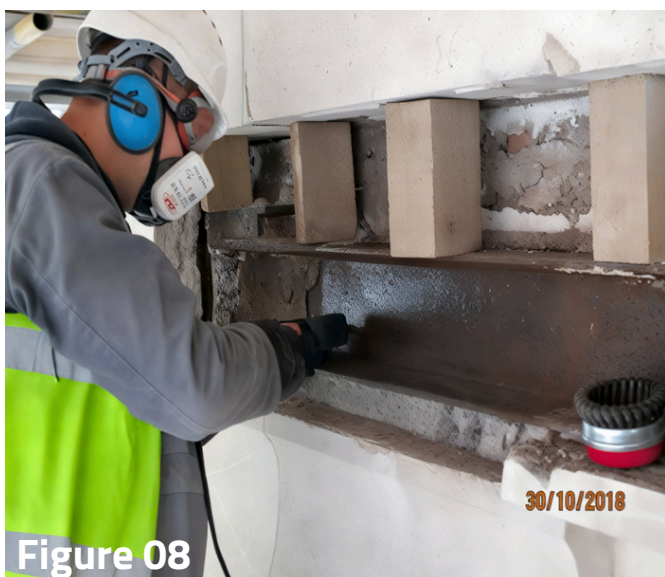
Where beams have had the concrete around them removed for an inspection, the concrete or stone above the beam is supported by machined bricks so that corroded beams can be treated and coated with ZINGA® before the concrete is replaced with fresh concrete or with a new layer of render. The one shown figure 08 is actually one of the areas within the walls of Shell Mex House.

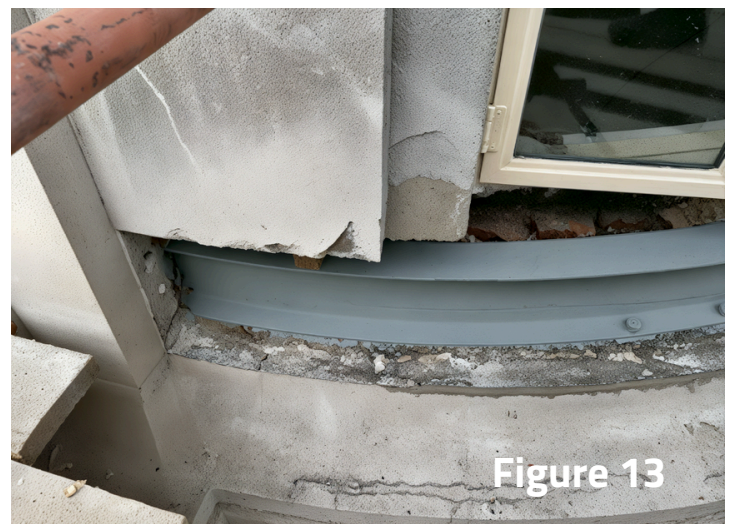
Figure 13

Well-trained technicians can access even some of the most awkward steel beams and successfully galvanise them before they are re-embedded in the concrete or lime render and then covered back in with stonework.
